AERIAL PHOTOGRAPHIC ANALYSIS OF GARY DEVELOPMENT LANDFILL

Gary, Indiana

ENVIRONMENTAL MONITORING SYSTEMS LABORATORY OFFICE OF RESEARCH AND DEVELOPMENT U.S. ENVIRONMENTAL PROTECTION AGENCY LAS VEGAS, NEVADA 89114

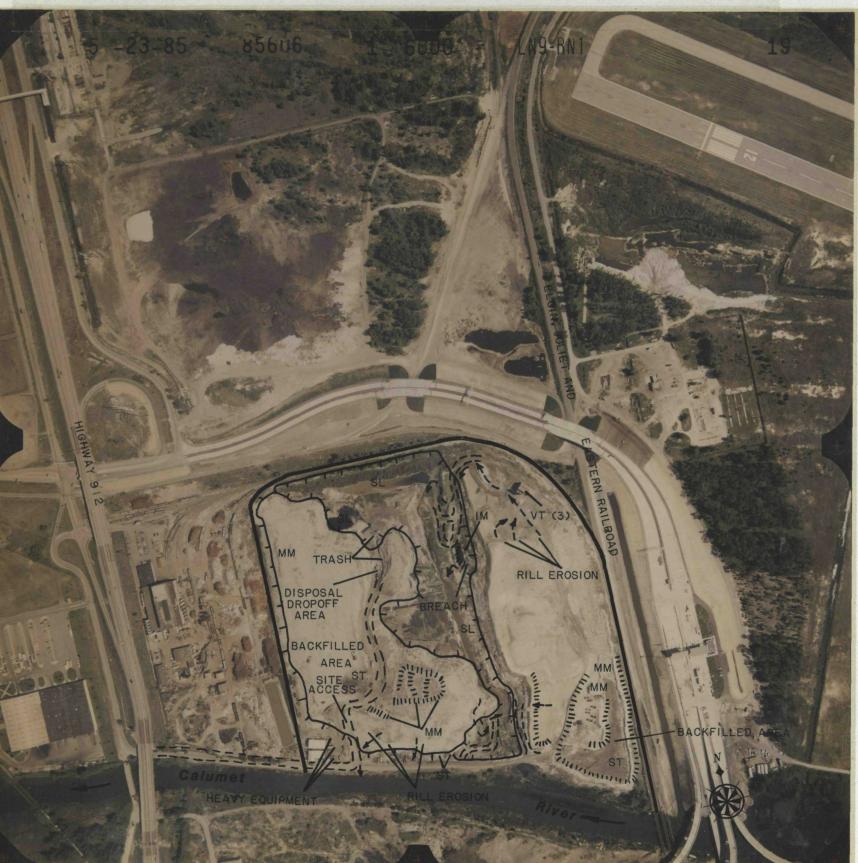
Figure 3. Gary Development Landfill, May 23, 1985. Approximate scale, 1 inch equals 277 feet.

The site appears to be an old gravel pit that is now an active waste disposal facility. Vehicles with trash in them are visible in the disposal dropoff area. Ground stains and rill erosion were present and three vertical tanks were located in the northeast corner of the site.

The Gary Development Landfill appears to be an old gravel pit that is being used for waste disposal. The active part of the landfill is in the pit on the western side of the site. There is a trash collection area at the end of the site access road and trucks are visible along the road. The western portion of the pit has probably been backfilled. The backfilled area extends from the south near the Calumet River to the north portion of the site. Standing liquid is visible at the bottom of the landfill. Heavy equipment is parked in the southwest corner of the site. North of the heavy equipment is a ground stain and some mounded material on the backfill mound. The backfilled area has some rill erosion along its southern side. There is also a ground stain along the southern side of this area. Some rill erosion is also visible in the northeast corner of the site. Runoff follows the erosion and eventually empties into the bottom of the pit. A building and three vertical tanks are north of the rill erosion. In the bottom of the landfill is a small impoundment that has a breach in its containment wall. In the southeast corner of the site is a large ground stain. This stained area may be a backfilled area. Material has been mounded to form berms in this section of the site.
